**SUBJECT: TRAFFIC AND SAFETY COMMITTEE ACTION ITEM  
FROM MEETING OF JANUARY 27, 2016 – ROLLING HILLS  
ROAD SOUTH OF LARIAT LANE IN-PAVEMENT WARNING  
LIGHTS FOR TRAIL CROSSING**

**SUBJECT: ROLLING HILLS ROAD SOUTH OF LARIAT LANE – IN-ROADWAY WARNING LIGHTS FOR TRAIL CROSSING**

Subject: REVIEW OF TRAIL CROSSING ON ROLLING HILLS ROAD SOUTH OF LARIAT LANE

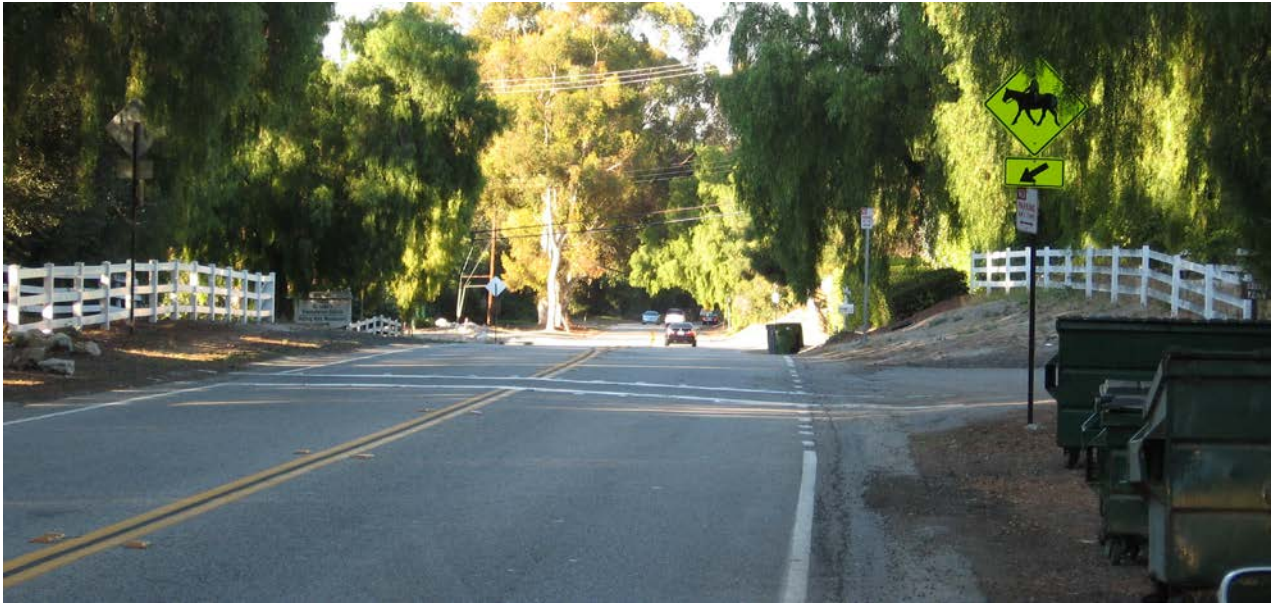
Rolling Hills Road at Trail Crossing Looking North

There is a marked trail crossing on Rolling Hills Road between Palomino Lane and Lariat Lane (at Palomino Ranchos Trail). The crosswalk is painted with two-foot wide lines, and is supplemented with a row of white reflective markers in both directions. Florescent yellow-green horse crossing signs are posted at the crosswalk in both directions with arrows. There is no street lighting in the area.

Field observations were made at the subject location. The horse crossing signs and markings are easily visible in advance of the crossing. However, the crossing is in shadow during much of the day due to the tree canopy, and equestrians waiting to cross may not be readily apparent to some drivers. The crossing is primarily used by equestrians during the week, with higher usage in early evening and weekends. Pedestrians occasionally use the same crossing in connection with church services on Sundays.

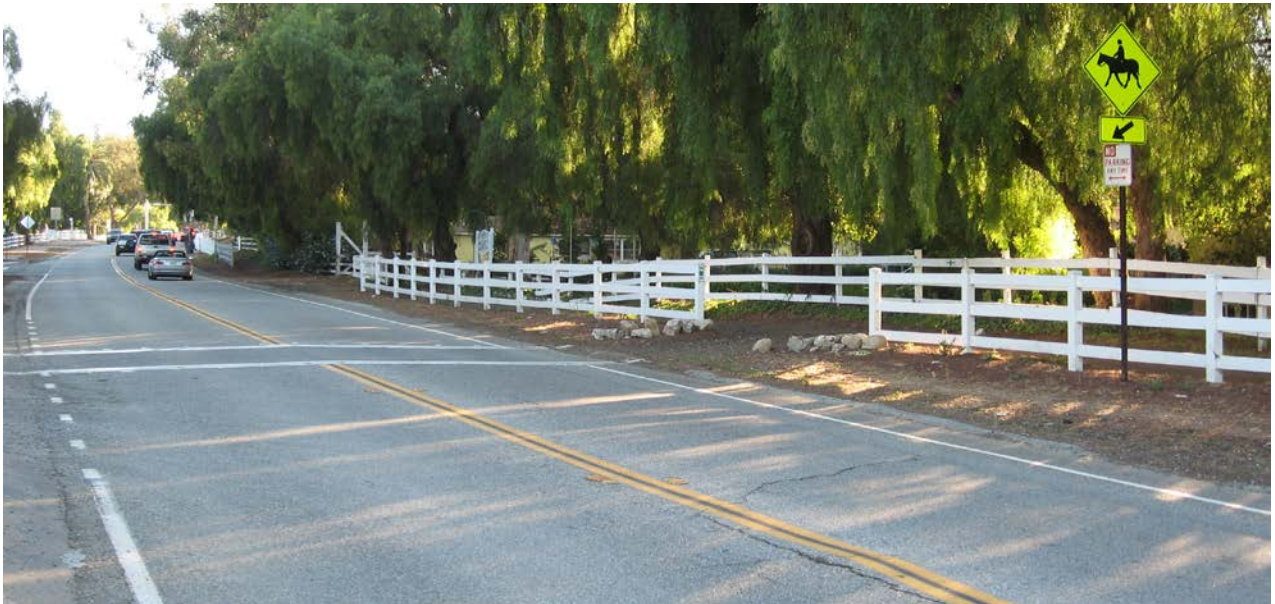
Rolling Hills Road at Trail Crossing Looking South

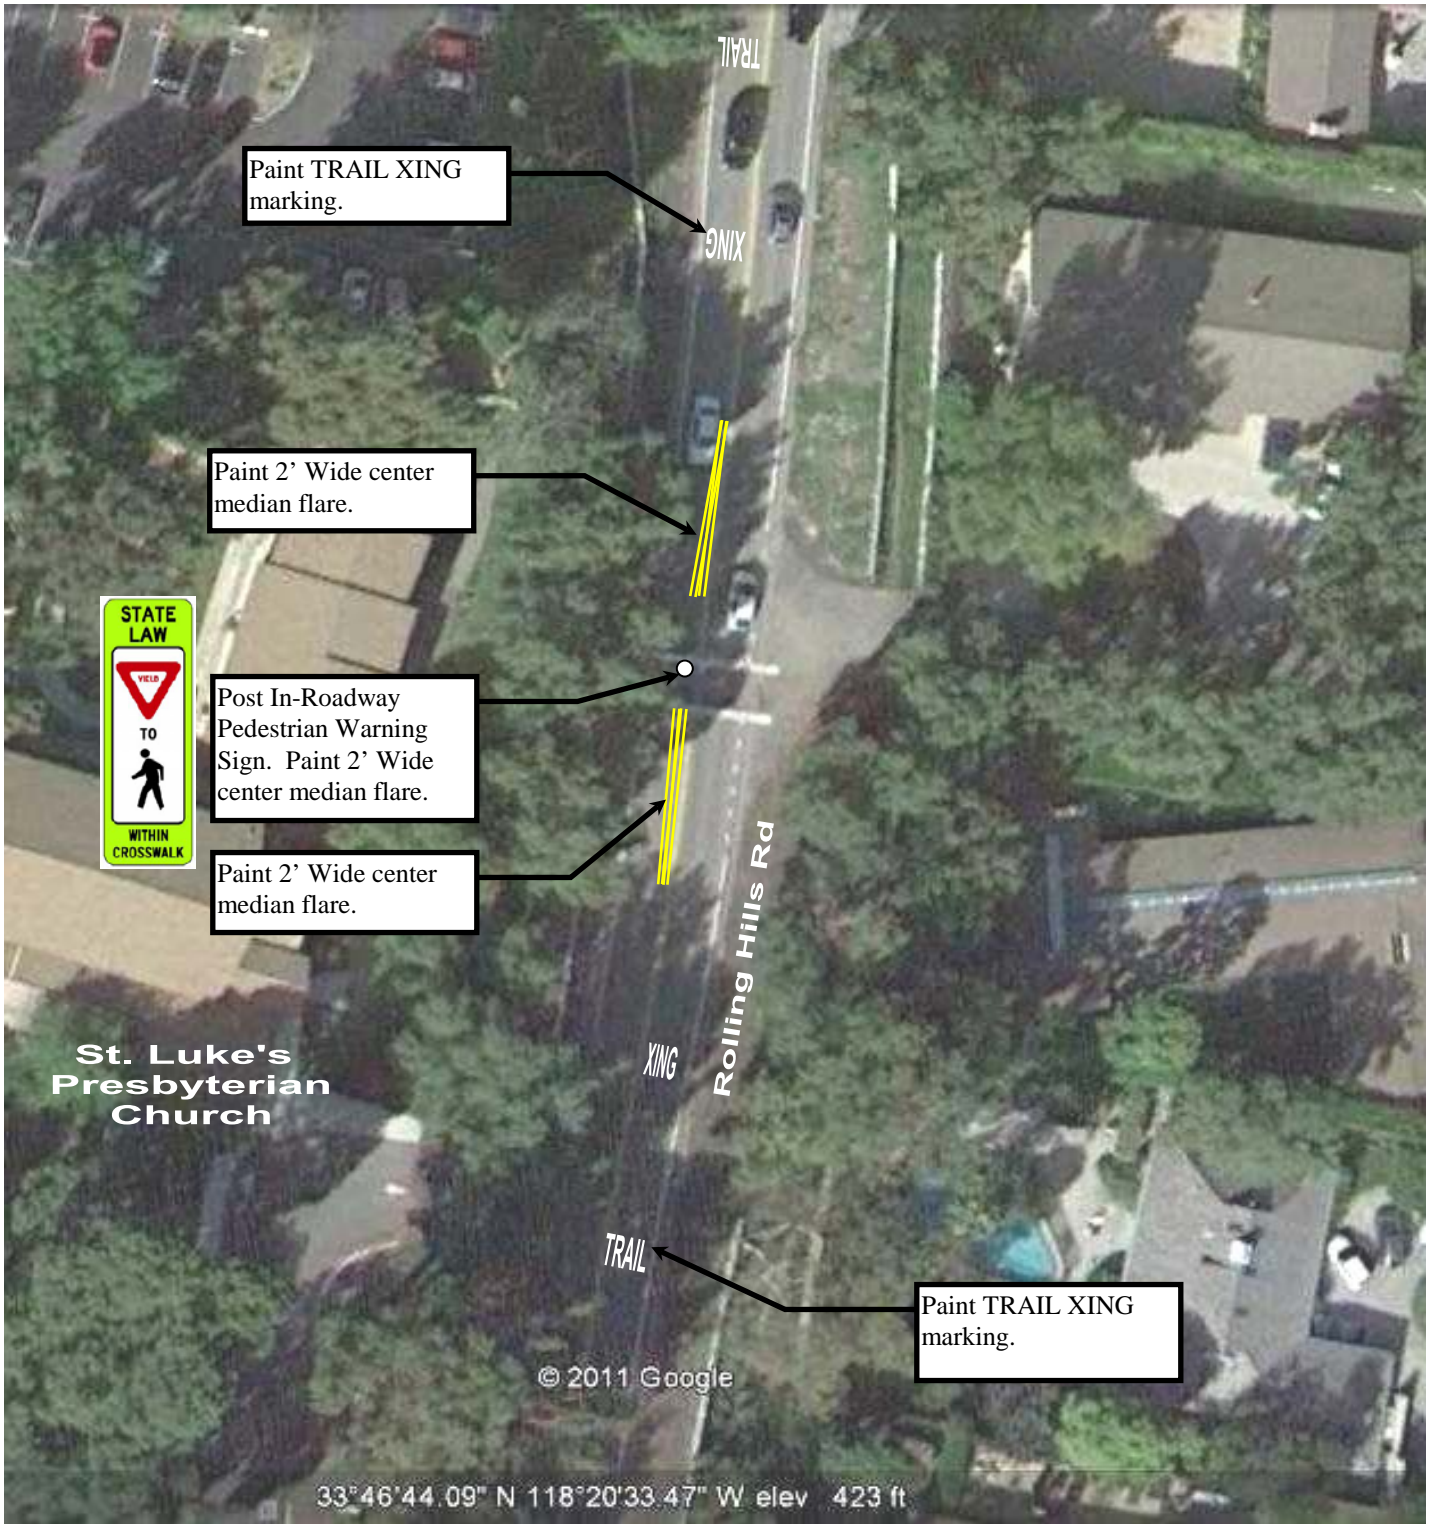
City of Rolling Hills Estates  
Traffic Engineering

**ROLLING HILLS ROAD**  
**North of**  
**Palomino Lane**  
**Install Enhanced Crosswalk Signs and Markings**

1. Paint "TRAIL XING" pavement markings on Rolling Hills Road in advance of the crosswalk to improve driver recognition of the mid-block crossing.
2. Post a two-sided in-roadway pedestrian warning sign and paint a center median at the crosswalk.
